Uniform Mitigation Verification Inspection Form

Inspection Date: 5/18/2023		
Owner Information		
Owner Name: LAKE CLARKE GARDENS HOA		Contact Person:
Address: 2668 N GARDEN DR.		Home Phone:
City: LAKE WORTH	Zip: 33461	Work Phone:
County: PALM BEACH		Cell Phone:
Insurance Company:		Policy #:
Year of Home: 1970	# of Stories: 3	Email:

Inspectors Initials BB **Property Address** 2668 N GARDEN DR. LAKE WORTH, FL

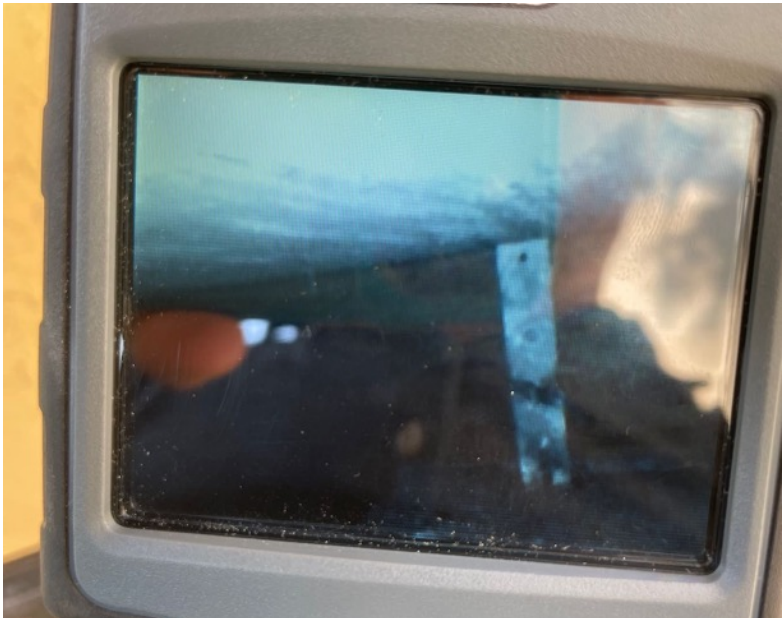
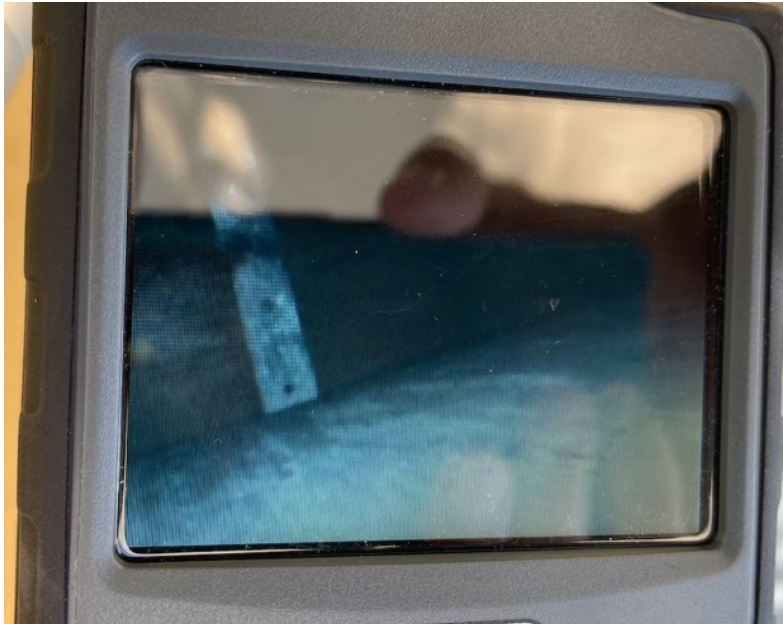
ROOF TO WALL CONNECTION:

Clip Connection found using Endoscope (Checked several locations and found to be consistent at multiple locations)
