Uniform Mitigation Verification Inspection Form

Inspection Date: 5/18/2023		
Owner Information		
Owner Name: LAKE CLARKE GARDENS HOA		Contact Person:
Address: 2812 S GARDEN DR.		Home Phone:
City: LAKE WORTH	Zip: 33461	Work Phone:
County: PALM BEACH		Cell Phone:
Insurance Company:		Policy #:
Year of Home: 1970	# of Stories: 3	Email:

WIND MITIGATION PICTURES:

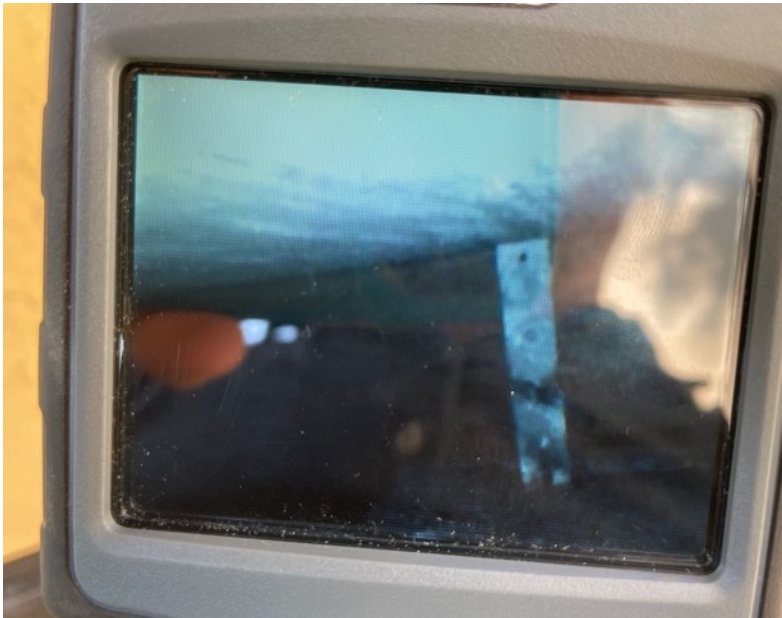
ROOF TO WALL CONNECTION:

Clip Connection found using Endoscope (Checked several locations and found to be consistent at multiple locations)

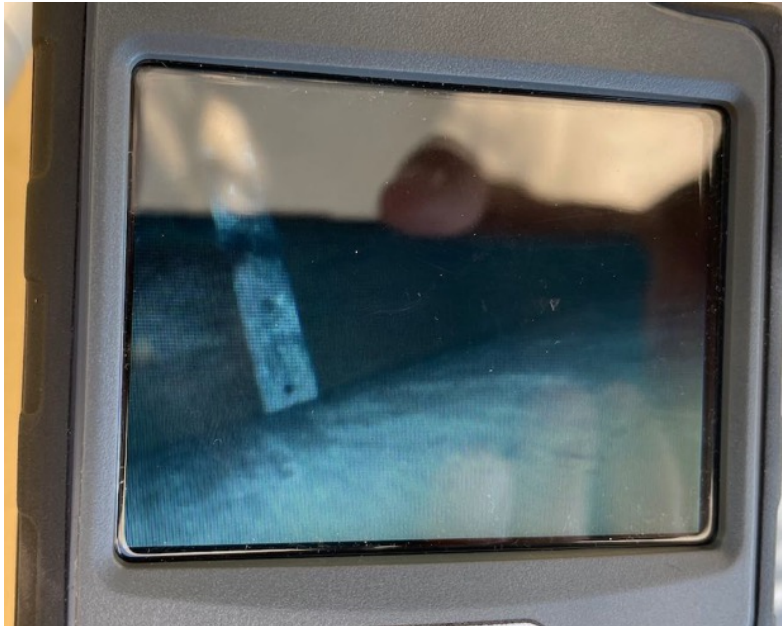
SHEETING/NAILING: Per FBC there are 8d nails in 4-6" spacing
