Uniform Mitigation Verification Inspection Form

Inspection Date: 5/18/2023		
Owner Information		
Owner Name: LAKE CLARKE GARDENS HOA		Contact Person:
Address: 2991 S GARDEN DR.		Home Phone:
City: LAKE WORTH	Zip: 33461	Work Phone:
County: PALM BEACH		Cell Phone:
Insurance Company:		Policy #:
Year of Home: 1972	# of Stories: 3	Email:

WIND MITIGATION PICTURES:

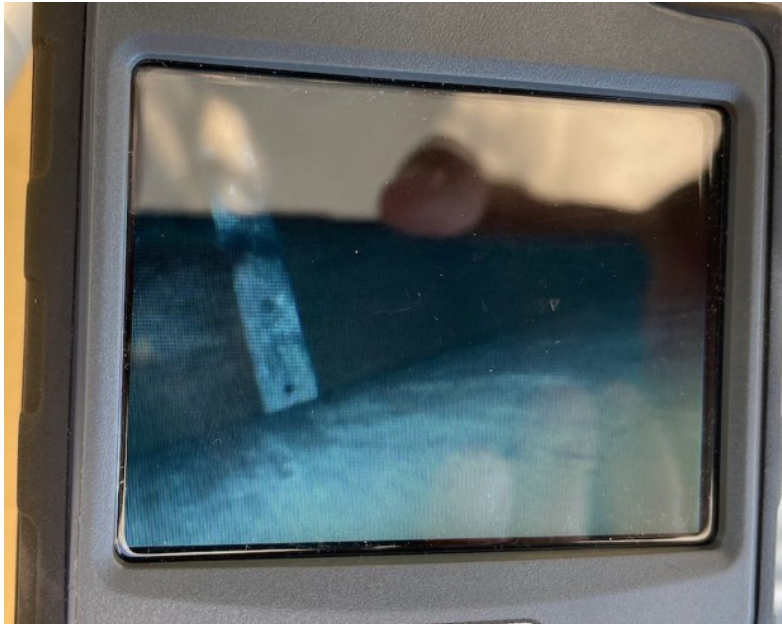
SHEETING/NAILING: Per FBC there are 8d nails with 4-6" spacing
