Uniform Mitigation Verification Inspection Form

Inspection Date: 5/18/2023		
Owner Information		
Owner Name: LAKE CLARKE GARDENS HOA		Contact Person:
Address: 2769 S GARDEN DR.		Home Phone:
City: LAKE WORTH	Zip: 33461	Work Phone:
County: PALM BEACH		Cell Phone:
Insurance Company:		Policy #:
Year of Home: 1971	# of Stories: 3	Email:

Inspectors Initials BB Property Address 2769 S GARDEN DR. LAKE WORTH, FL

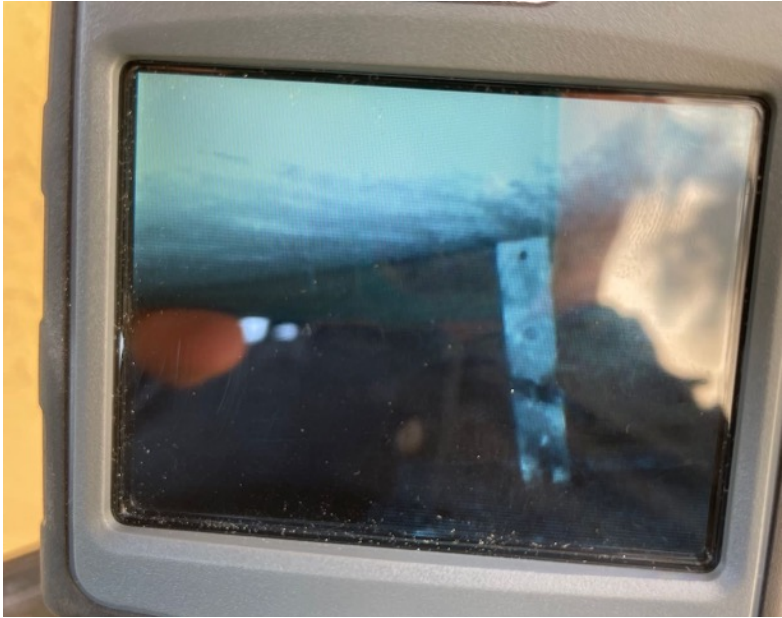
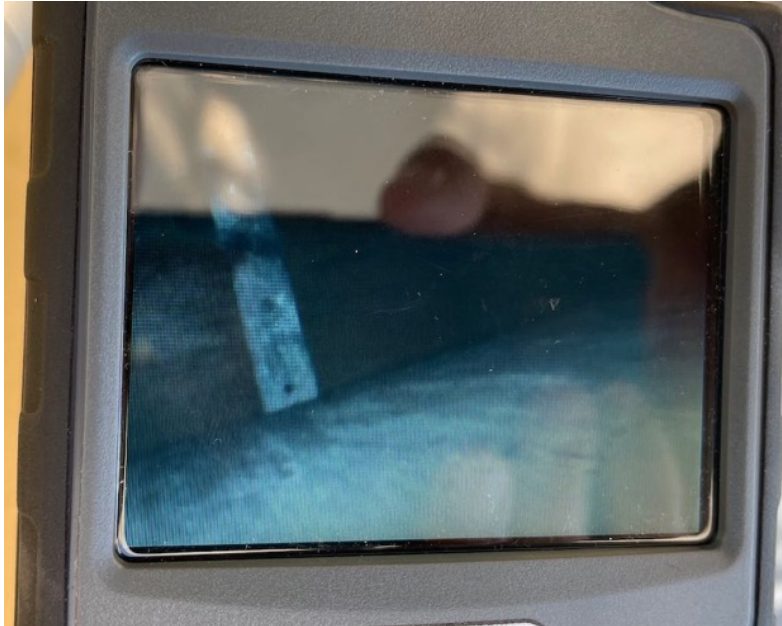
ROOF TO WALL CONNECTION:

Clip Connection found using Endoscope (Checked several locations and found to be consistent at multiple locations)
