Uniform Mitigation Verification Inspection Form

Inspection Date: 5/18/2023		
Owner Information		
Owner Name: LAKE CLARKE GARDENS HOA		Contact Person:
Address: 2606 S GARDEN DR.		Home Phone:
City: LAKE WORTH	Zip: 33461	Work Phone:
County: PALM BEACH		Cell Phone:
Insurance Company:		Policy #:
Year of Home: 1969	# of Stories: 3	Email:

Inspectors Initials BB Property Address 2606 S GARDEN DR. LAKE WORTH, FL

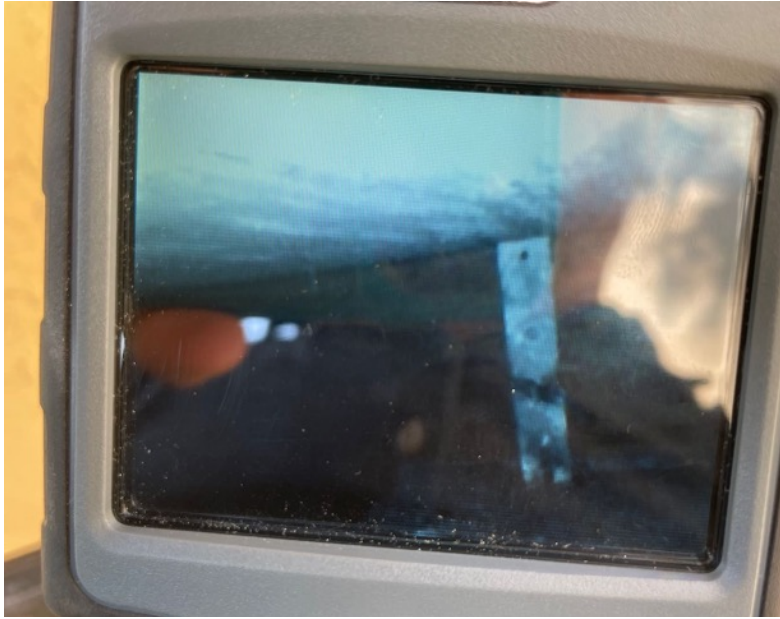
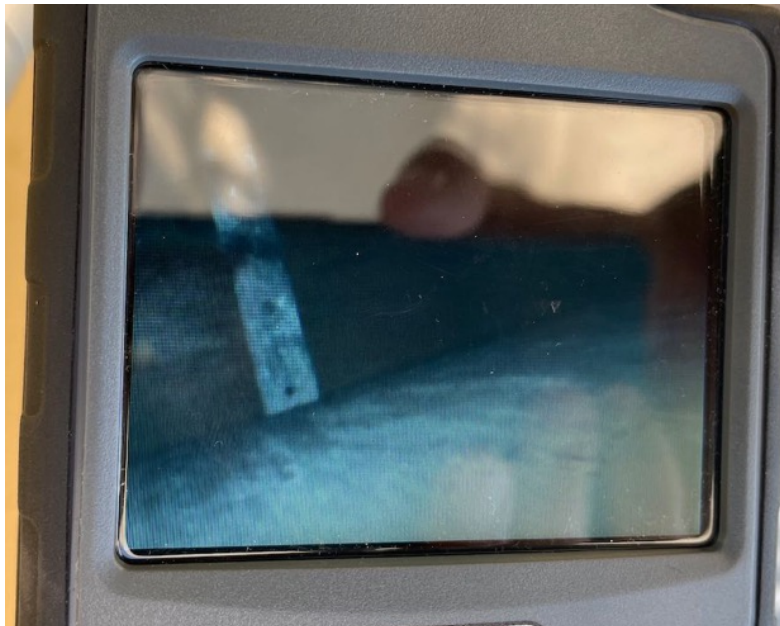
ROOF TO WALL CONNECTION:

Clip Connection found using Endoscope (Checked several locations and found to be consistent at multiple locations)
