Uniform Mitigation Verification Inspection Form

Inspection Date: 5/18/2023		
Owner Information		
Owner Name: LAKE CLARKE GARDENS HOA		Contact Person:
Address: 2724 S GARDEN DR.		Home Phone:
City: LAKE WORTH	Zip: 33461	Work Phone:
County: PALM BEACH		Cell Phone:
Insurance Company:		Policy #:
Year of Home: 1969	# of Stories: 3	Email:

WIND MITIGATION PICTURES:

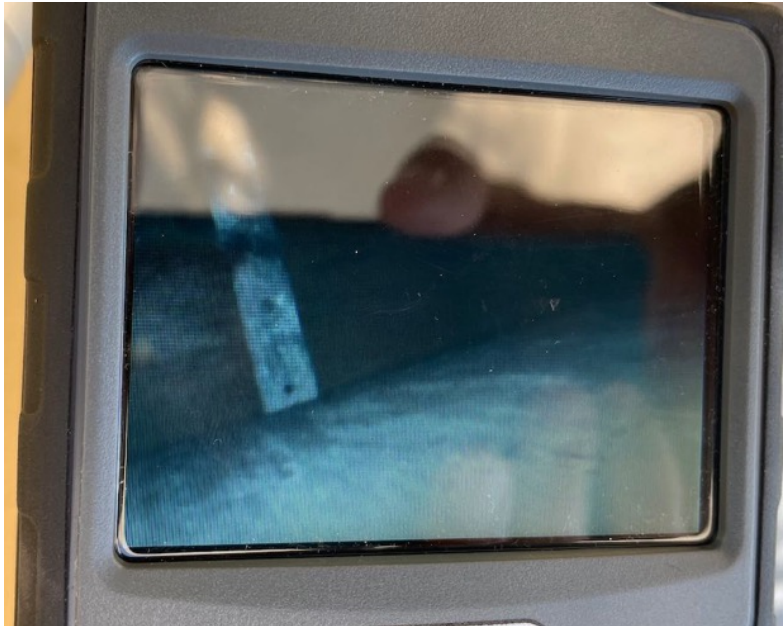
SHEETING/NAILING: Per FBC there are 8d nails at 4-6" spacing
