# Uniform Mitigation Verification Inspection Form

Inspection Date: 5/18/2023		
<b>Owner Information</b>		
Owner Name: LAKE CLARKE GARDENS HOA		Contact Person:
Address: 2811 S GARDEN DR.		Home Phone:
City: LAKE WORTH	Zip: 33461	Work Phone:
County: PALM BEACH		Cell Phone:
Insurance Company:		Policy #:
Year of Home: 1971	# of Stories: 3	Email:

WIND MITIGATION PICTURES:

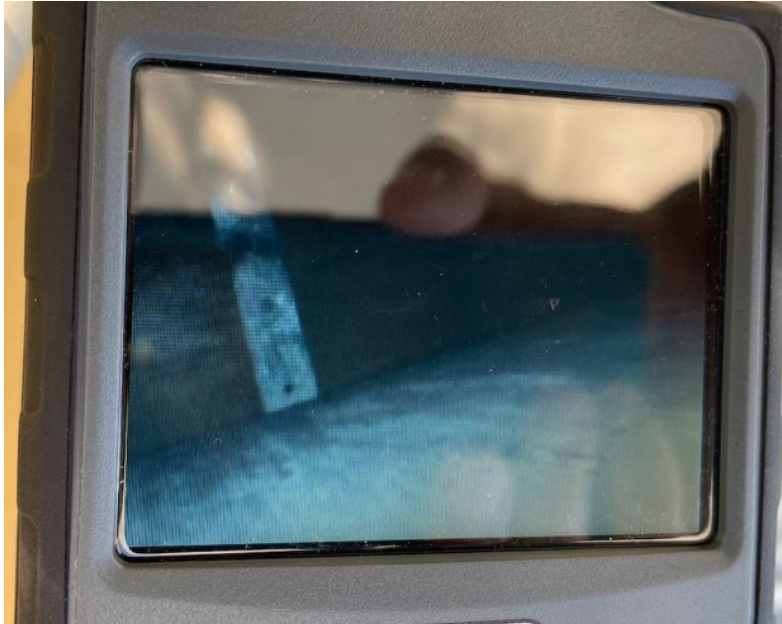
ROOF TO WALL CONNECTION:

Clip Connection found using Endoscope (Checked several locations and found to be consistent at multiple locations)
