Uniform Mitigation Verification Inspection Form

| Owner Name: LAKE CLARKE GARDENS HOA | | Contact Person: |
| Address: 2855 S GARDEN DR. | | Home Phone: |
| Year of Home: 1971 | # of Stories: 3 | Email: |

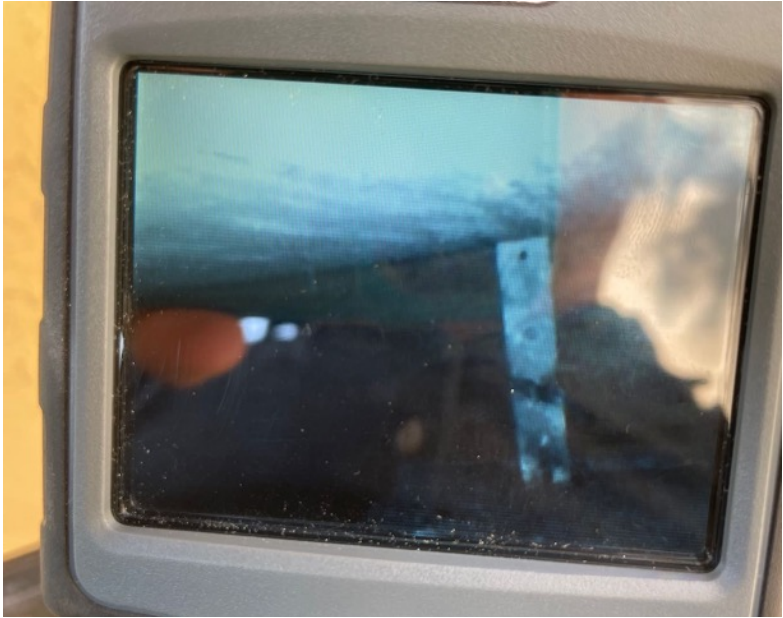
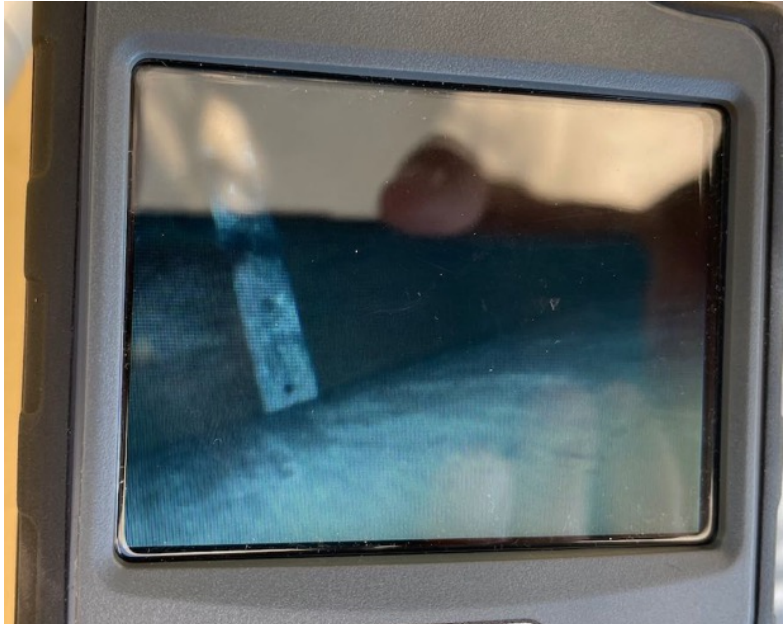
ROOF TO WALL CONNECTION:

Clip Connection found using Endoscope (Checked several locations and found to be consistent at multiple locations)
